SC0003

10 November 2017

Replacing/refitting Star Cool/MCI temperature supply sensors.

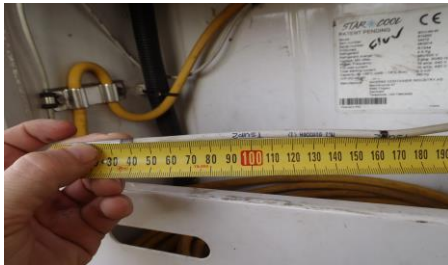
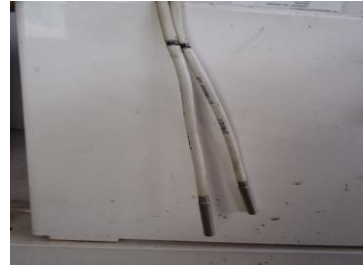
1. Ensure both sensors are fully inserted in to the sensor pocket.
2. Use the below container build information to obtain the correct sensor depth for the corresponding sensor pockets.
3. Measure and mark the sensors to the required length (measurements must be taken from the tip of the sensor to required length and mark each sensor wire.
