E107> Discharge temperature too high (DCHS).
EEV opening is abnormal for 5 minutes.

E109 > Low Pressure Transducer reading lower than -90kPa for 2 seconds

Expansion valve coil replacement

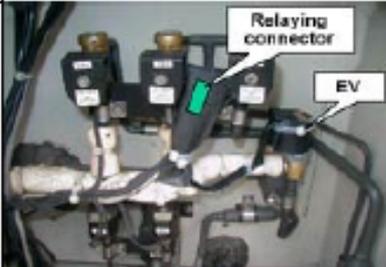
<p>On the picture you see where the EV is located.</p>	<p>Please note circuit breaker must turn off during all this work to be correct initialization of EV coil.</p>
2
