E107> Discharge temperature too high (DCHS).
EEV opening is abnormal for 5 minutes.

E109 > Low Pressure Transducer reading lower than -90kPa for 2 seconds

Expansion valve coil replacement

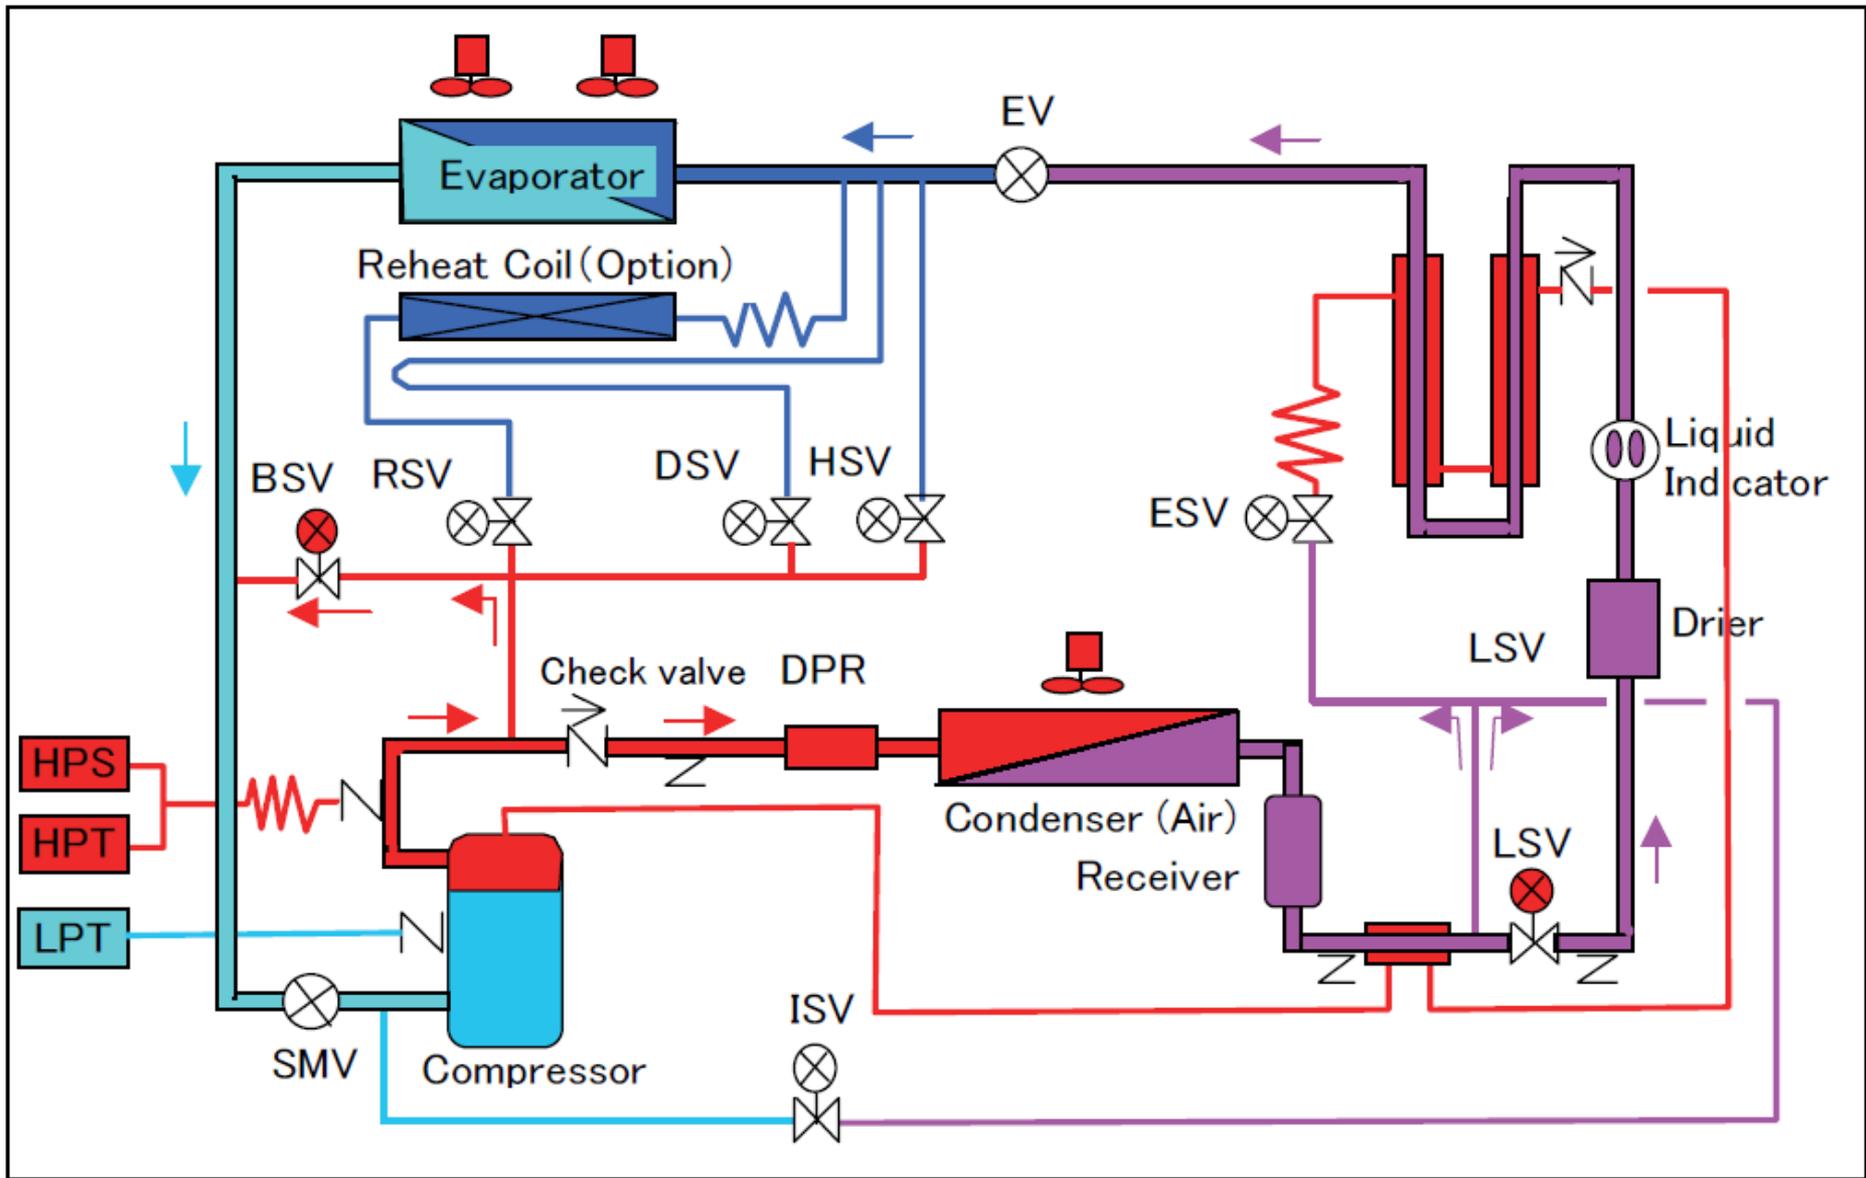
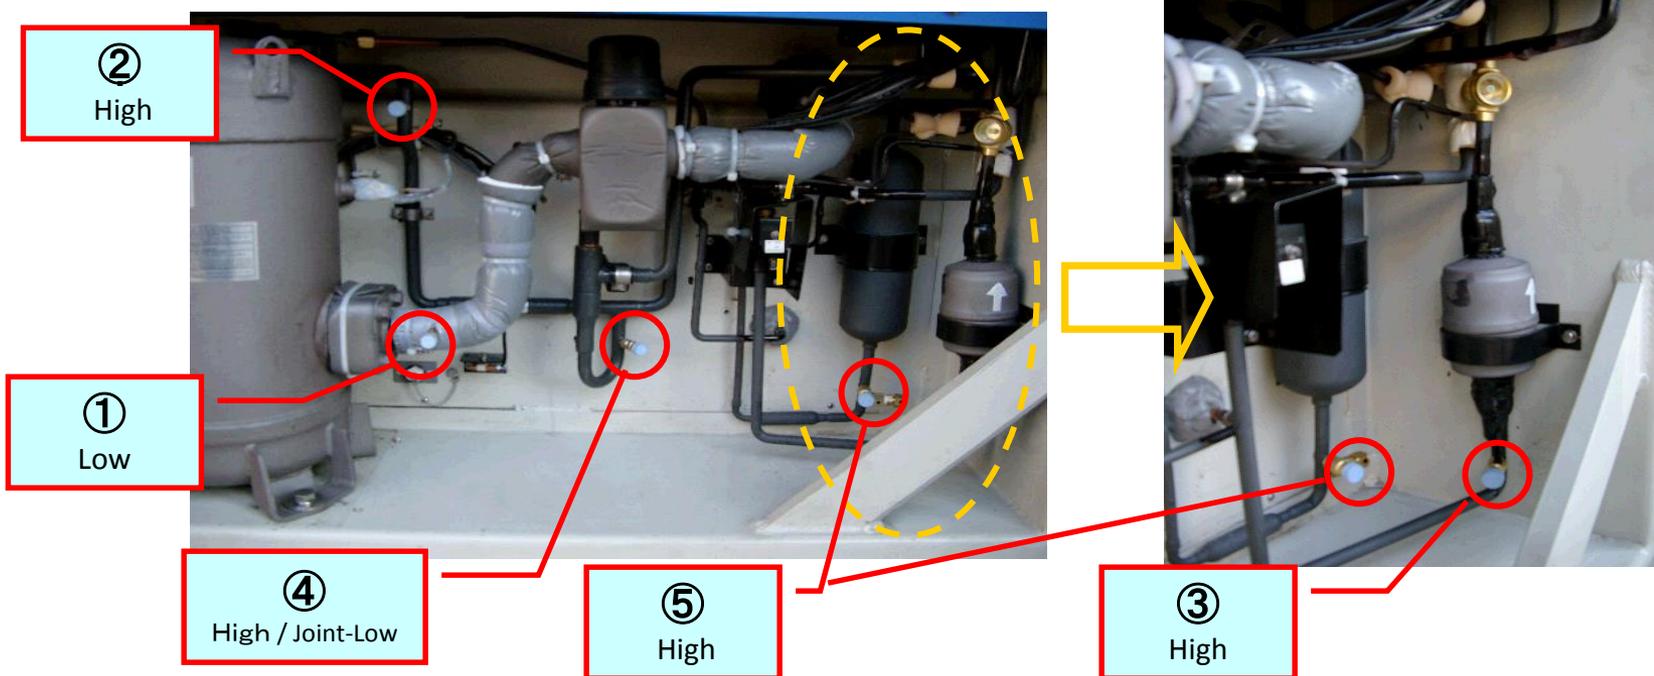
Service ports in Piping Diagram

Service work		Service port	Remarks
Pressure check	High press.	②	Take care that the high pressure at the port ④ & ⑤ will be keeping a while after the unit stops.
	Low press.	①	
Refrigerant charge	1.Refrigerant recovery	④ & ⑤	Recover refrigerant from ④ & ⑤ after operating automatic pump-down first
	2.Vacuum & Dehydration	④ & ⑤	After recovering, vacuum from port ④ & ⑤.
	3.Liquid charging	⑤→③	After vacuuming, charge liquid refrigerant from ⑤ first and the from ③.
③		If not reached to the specified amount, go to next below. 1.Operate automatic pump-down first and stop it using ON/OFF switch when the compressor stops during the auto pump-down operation. 2.Charge liquid refrigerant from port ③.	
Daikin Service	Rdam 001

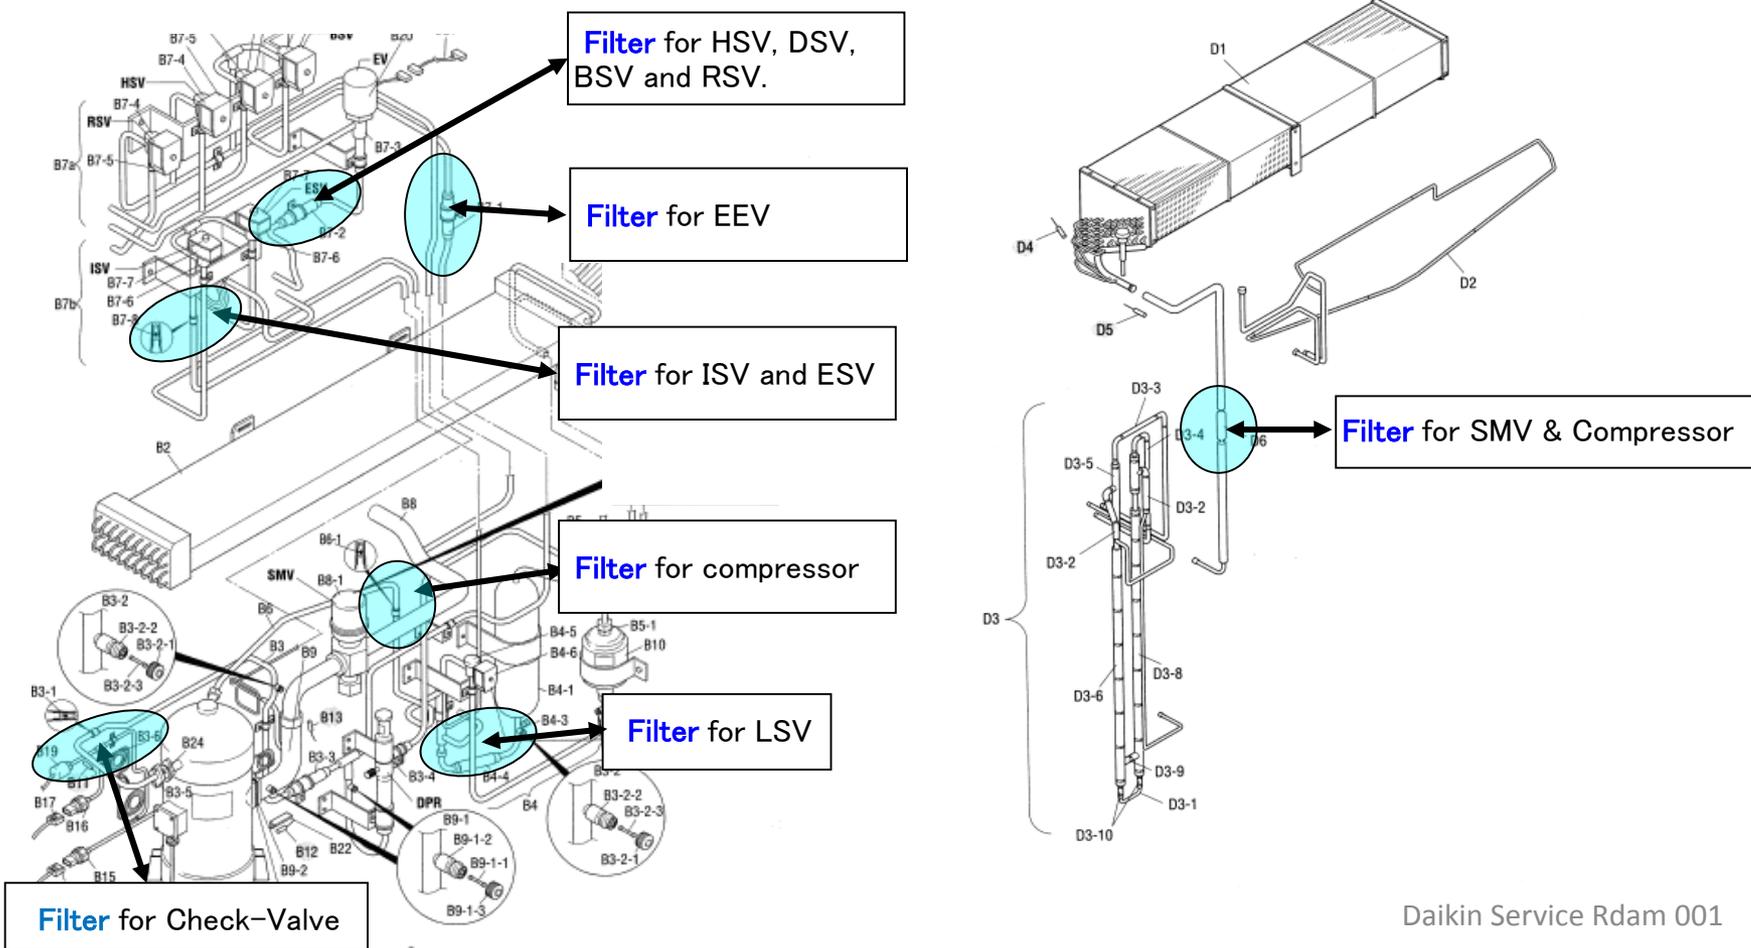
- * E101 > blockage of filter/strainer at check-valve,
- * E107 or E109 > blockage of filter/strainer at LSV or EEV

To judge clogged filter/strainer, check piping temperature before & after filter/strainer for big temperature differences or measure pressures drops over the service ports.

In case of blockage remove and clean/replace the filter/strainer.
